LASER SCANNER SURVEY TO CULTURAL HERITAGE CONSERVATION AND RESTORATION

Present study is focused on finding a workflow to support activity of study, restoration and conservative project of cultural heritage, extracting automatically (or with a limited manual operation) graphic outputs from laser scanner survey. Some procedure was tested on two case study the Siviller Castle (XV century), situated in Villasor, a city near Cagliari (Sardinia, Italy) and the tower bell of Mores, near Sassari (Sardinia, Italy).

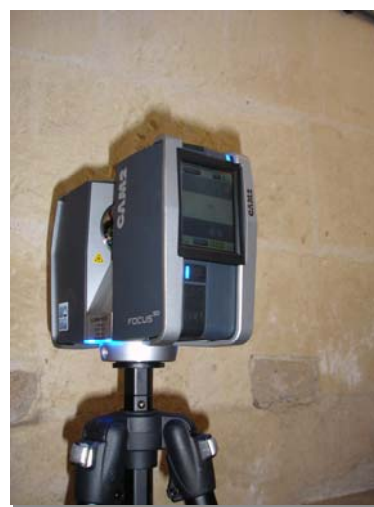
Fig. 3. Faro Focus 3D Laser Scanner

To perform scans was used a laser scan Focus3D by Faro. Instrument was designed to obtain a laser scanner lightweight and with a high potential for documenting internal and external applications for architecture, restoration and industrial. It's a scanner with high-speed and contained size (24 cm x20 cm x10 cm) and weight (5 kg). It's equipped with a WLAN (WiFi) that allow you to start, to stop, and to download scans also at a distance to site.

Characteristic of this compact instrument is a range from 0.6 m to 120 m with an error of linear distance equal ± 2 mm for a distance between scanner and object included in a range from 10 to 25 meters and a noise (standard deviation of the values from the best-fit plan) variable from 0.6 mm to 10 m with a 90% reflectivity and from 2.2 mm to 25 m with a 10% reflectivity. It also has a vertical visual field of 305° and the horizontal one of 360°. Both horizontal and vertical resolution is 0.009°. Laser scanner Focus 3D has a scansion speed of 976.000 dot/sec. A colour digital camera with a 70 megapixel resolution is integrated in laser scanner.

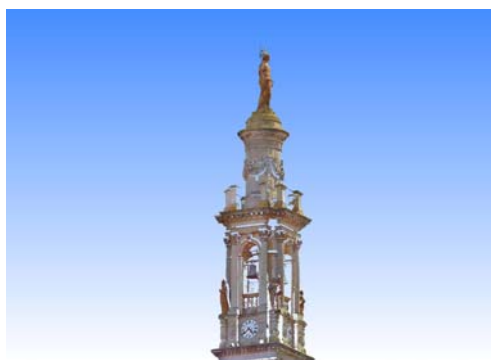
Fig. 4: Point clouds

The following figures show results obtained from processing of points cloud with JRC Reconstructor 2.

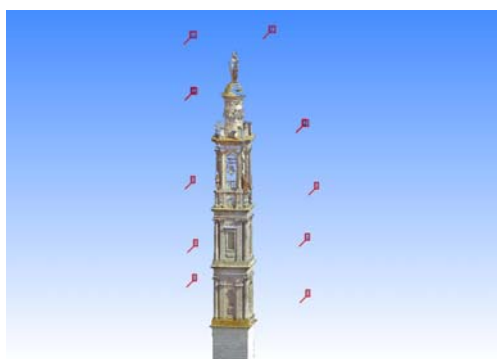
Fig. 5: Points of scans

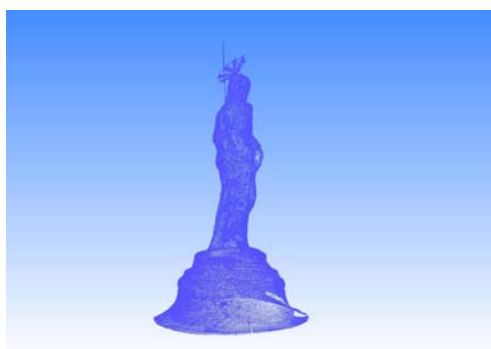
Fig. 6: Statue with contour line

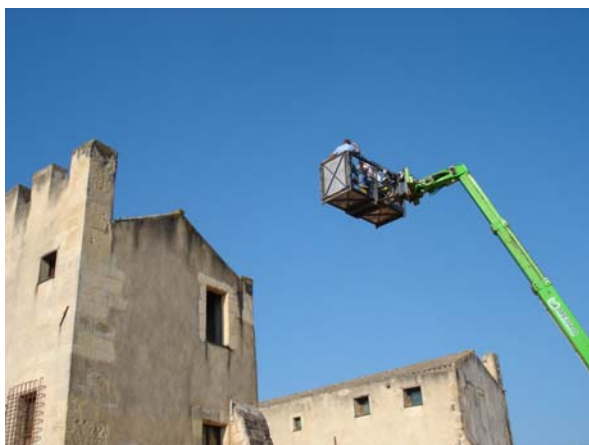
Fig. 8: Lifting platform to roof survey

In order to have a complete survey of the castle without empty and a good number of overlapping scans (at least 30% of them), we made 61 scans with a resolution of 7 mm. Scans were made on ground except for 3 that were acquired by a lifting platform in order to survey the roof.

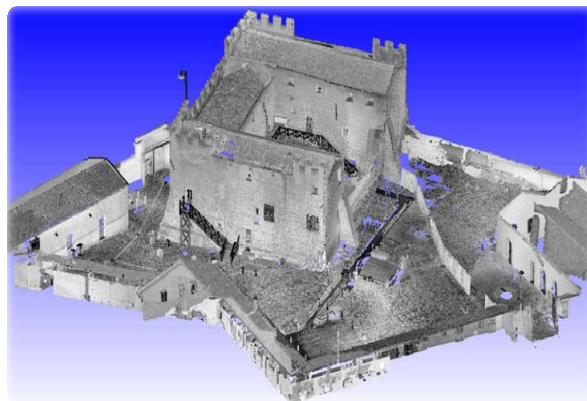
Fig. 9: Sivillier Castle 3D model

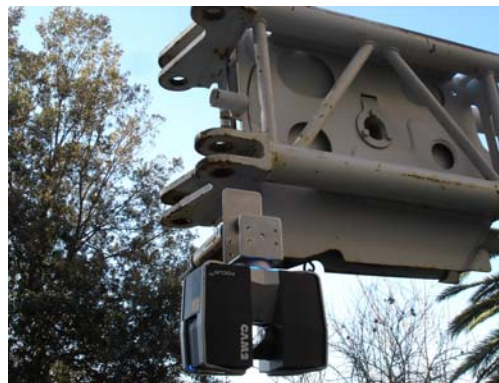
Fig. 12: Laser scanner on the crane boom

Due to considerable height of bell tower, about 40 m, many scans were made by mounting laser scans on crane boom that leads up scanner to right height. This way allowed us to perform scans of the bell tower and statues at a distance of approximately 10 m of the portions to be scanned, thus avoiding all the complications of geometric scans made with inclination beam too high.

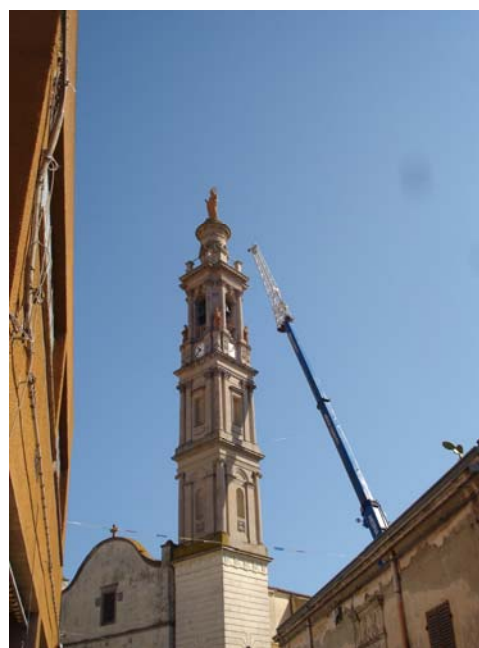
Fig. 13: Laser scanner survey of the Bell Tower

In order to have a complete survey of the tower bell and statues without empty and a good number of overlapping scans (at least 30% of them), we made 93 scans with a resolution of 7 mm (only statues scans were made with resolution of 3 mm).

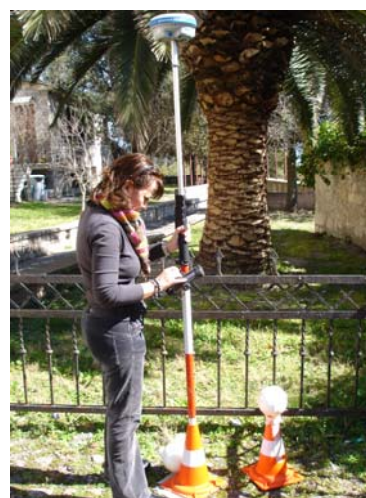
Fig. 14: GPS survey to georeference scans
